### **Land East of Ansty Way – Response to Sport England Comments**

**Beech Farm Field**  
**Playing Field Performance Quality Standard Assessment**

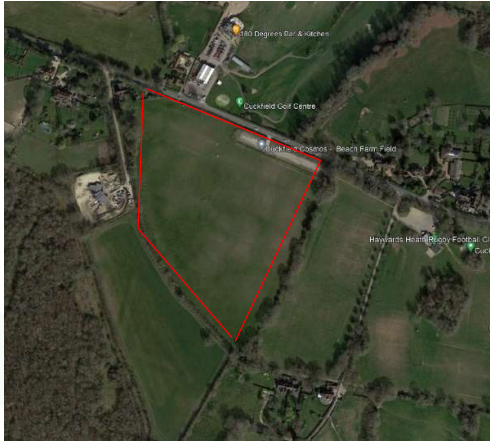
Figure 1 – Existing Beach Farm Field site

Existing pitches at Beach Farm Field, Haywards Heath, RH17 5HY.

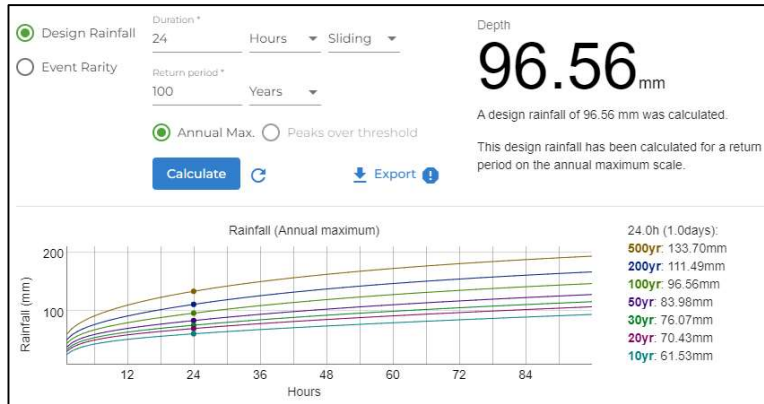
Figure 2 –Rainfall modelling

100mm/hr through time. Appreciation to the extent of flash floods, prolonged rainfall periods and assurance of retaining surface water upon the site so that it does not become detrimental to flooding to properties and facilities further down stream.

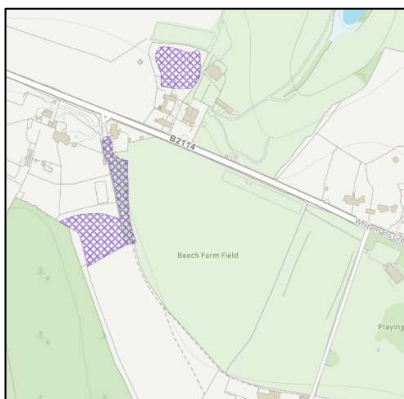
Figure 3 –areas of historic landfill

Records show areas to the west boundary of the site being a historic landfill (figure 3).

The historic landfill appears to be outside the curtilage of the field under inspection.

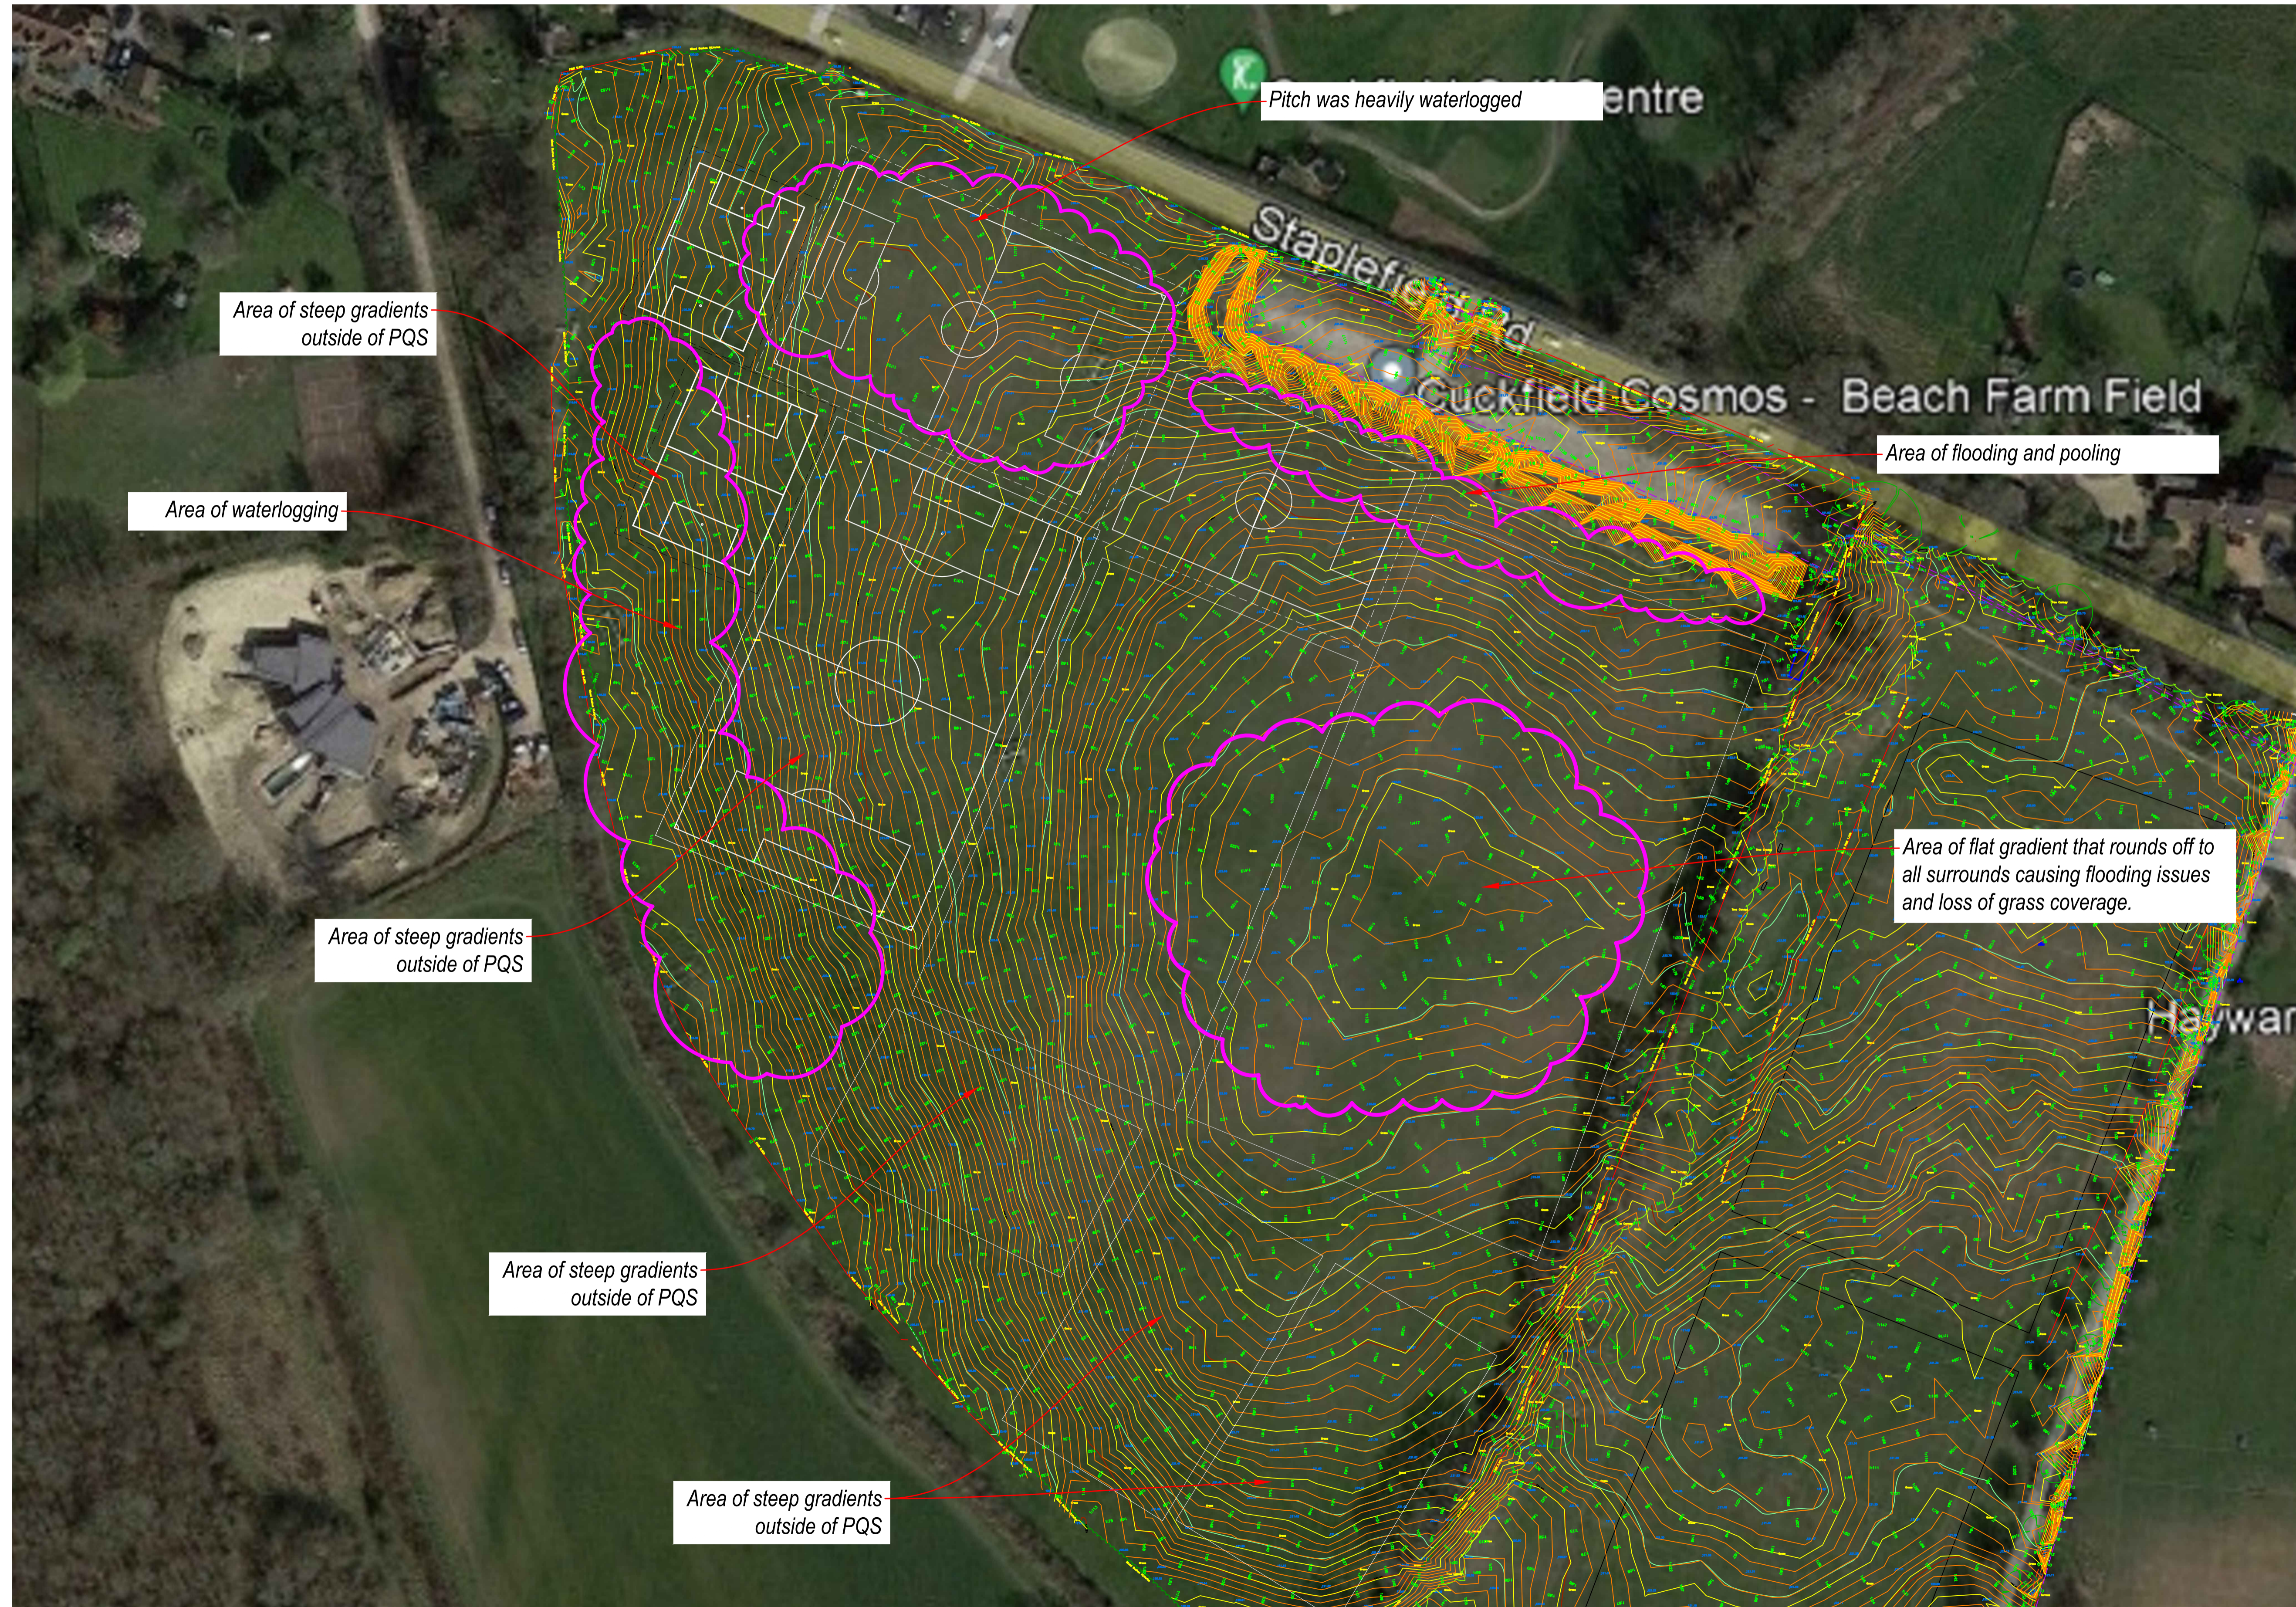
00	FEASIBILITY ISSUE	WB	16/01/24
REV	DESCRIPTION	REV CK	DATE
<b>NTS</b> Natural Turf Solutions SPORTS PITCH CONSULTANTS			
AUTHOR WB			
TITLE <b>Cuckfield Playing Fields</b> Sports Pitches Existing Gradients			
PROJECT	SCALE	SIZE	
NTS219	NTS	A1	
DRAWING No	REVISION		
02	00

The approximate pitch gradients are shown within the attached plan NTS219 02 - Existing Gradients. The area to the east of the site has a humped feature through the centre of the main rugby pitches and training areas. The area flattens off through the centre and then gradients run off severely to all directions. The flattened area is the most severely impacted by waterlogging and surface damage with loss of grass growth.
