ANSTY GARDEN COMMUNITY,

DESIGNERS RESPONSE

REPORT REF NO. 2207280-R16A

Stage 1 Road Safety Audit

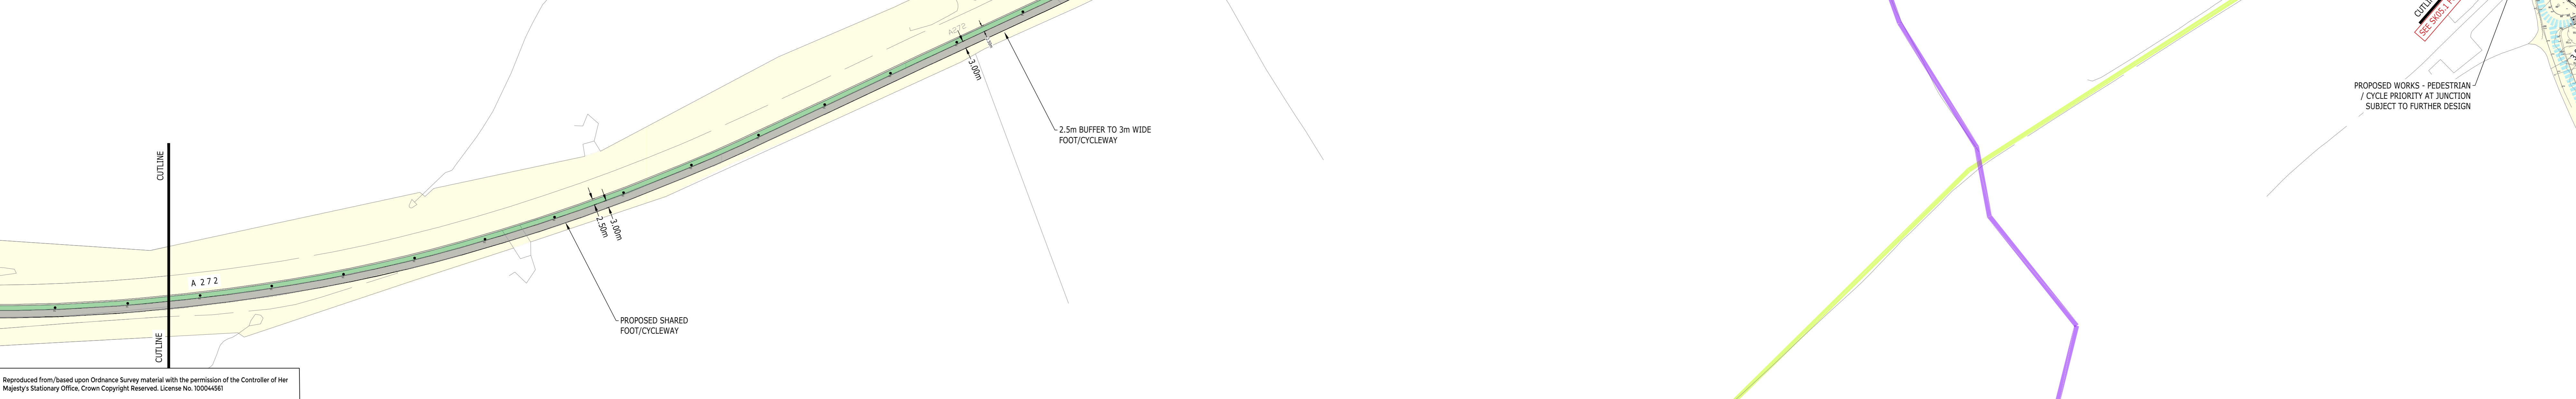
Drawing Number: **2207280-SK05** Rev: **H**

Drawing Title: **CYCLE ROUTE IMPROVEMENT PLAN (SHEET 1)**

VEGETATION WITHIN VISIBILITY SPLAYS TO BE TRIMMED AND CUT BACK TO KEEP VISIBILITY SPLAYS CLEAR. MATURE TREES TO HAVE REFLECTIVE BANDING.

ANY STREET FURNITURE TO BE RELOCATED IS TO BE POSITIONED TO THE BACK OF THE FOOT/CYCLEWAY.

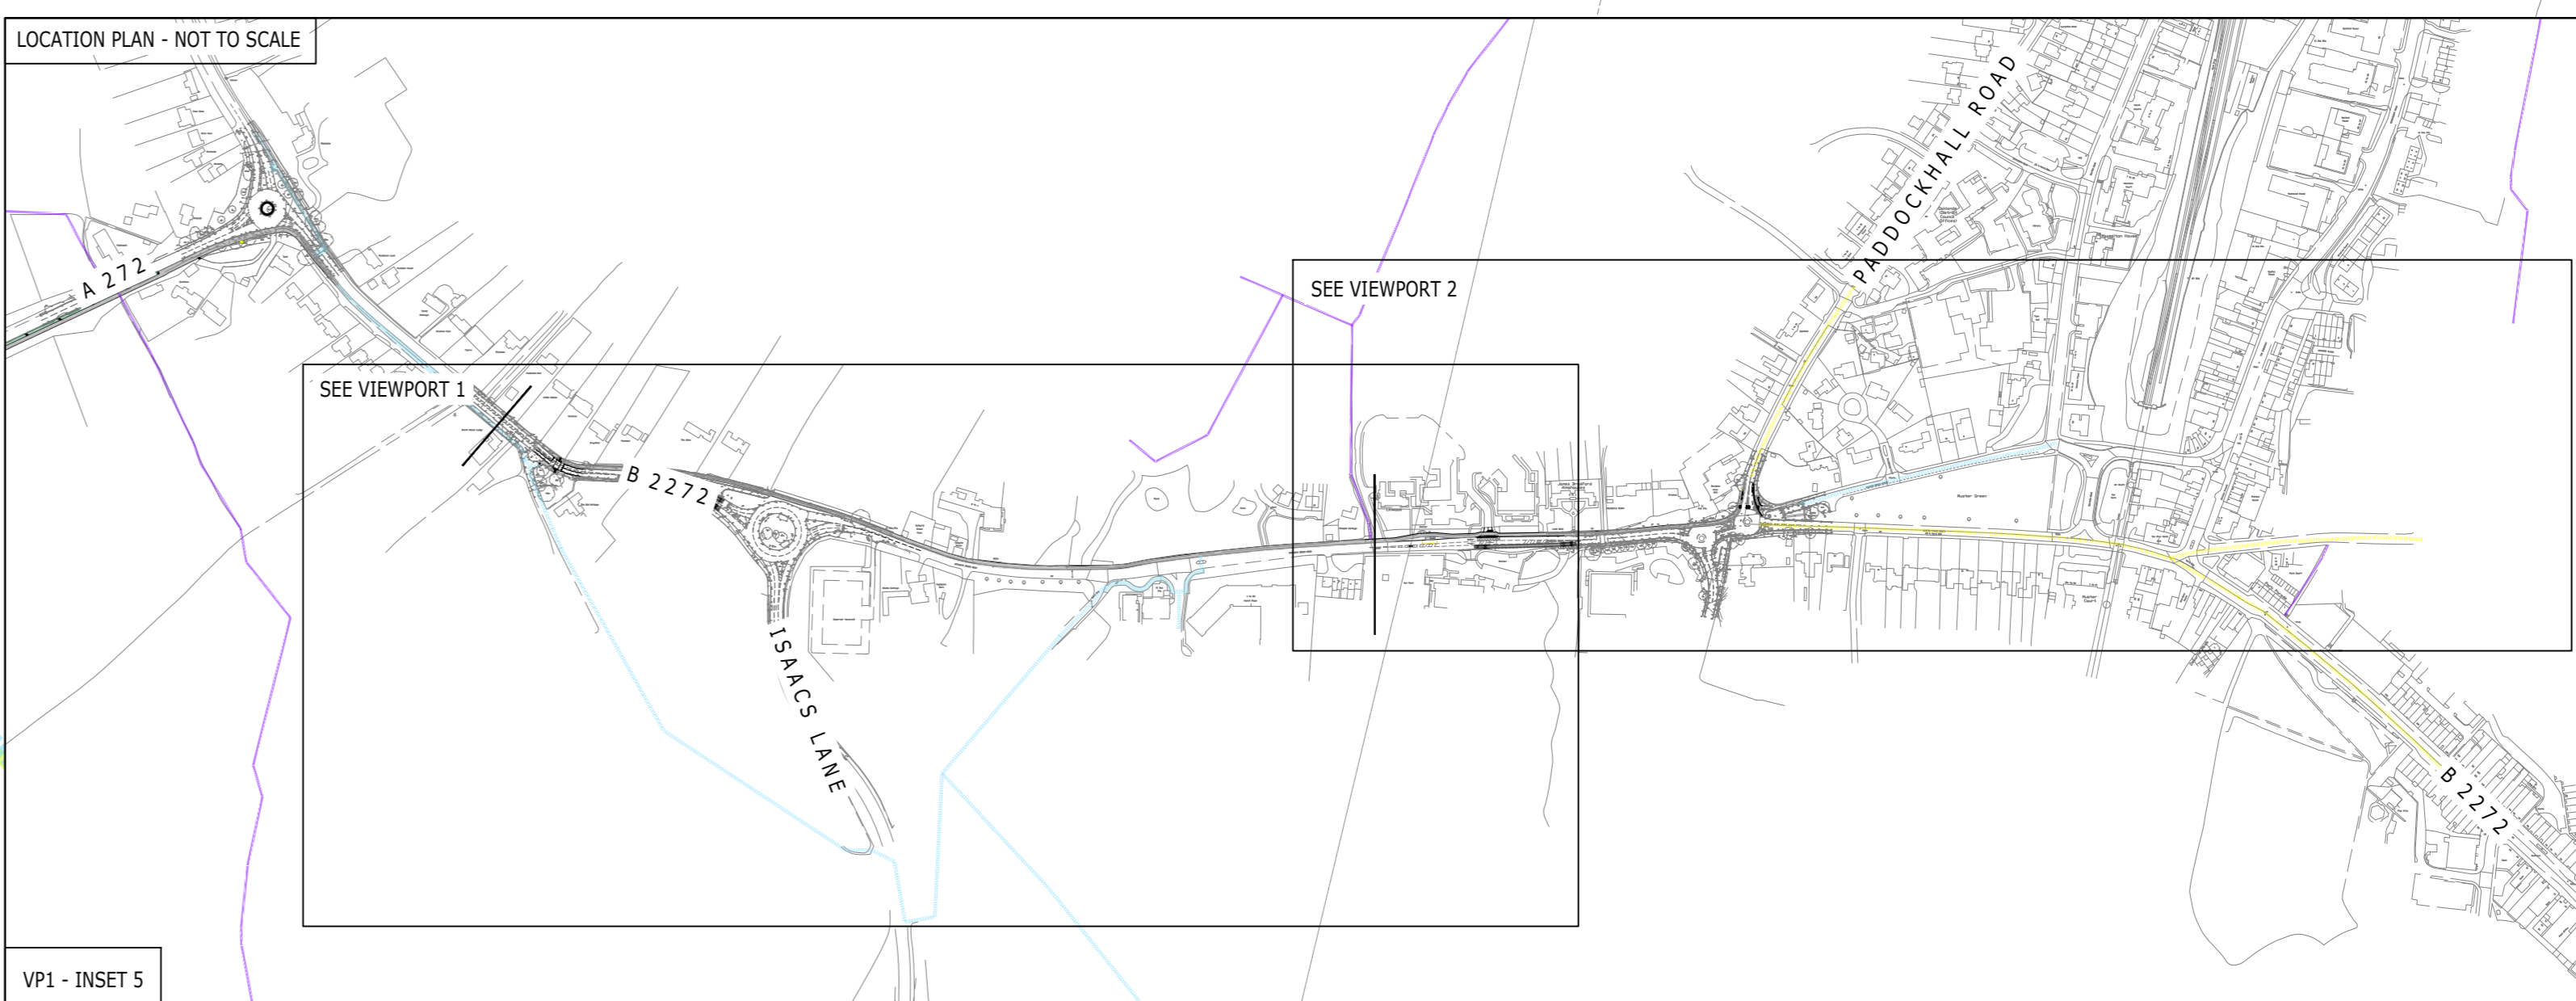
Drawing Number: **2207280-SK05.1** Rev: **H**

Drawing Title:
CYCLE ROUTE IMPROVEMENT PLAN (SHEET 2)
