## The Old Brickworks, Reeds Lane Sayers Common

**Arboricultural Implications Report**

## Arboricultural Implications Report Proposed re-development at Reeds Lane Sayers Common West Sussex BN6 9LS

Ref. SJA air 17182-01a

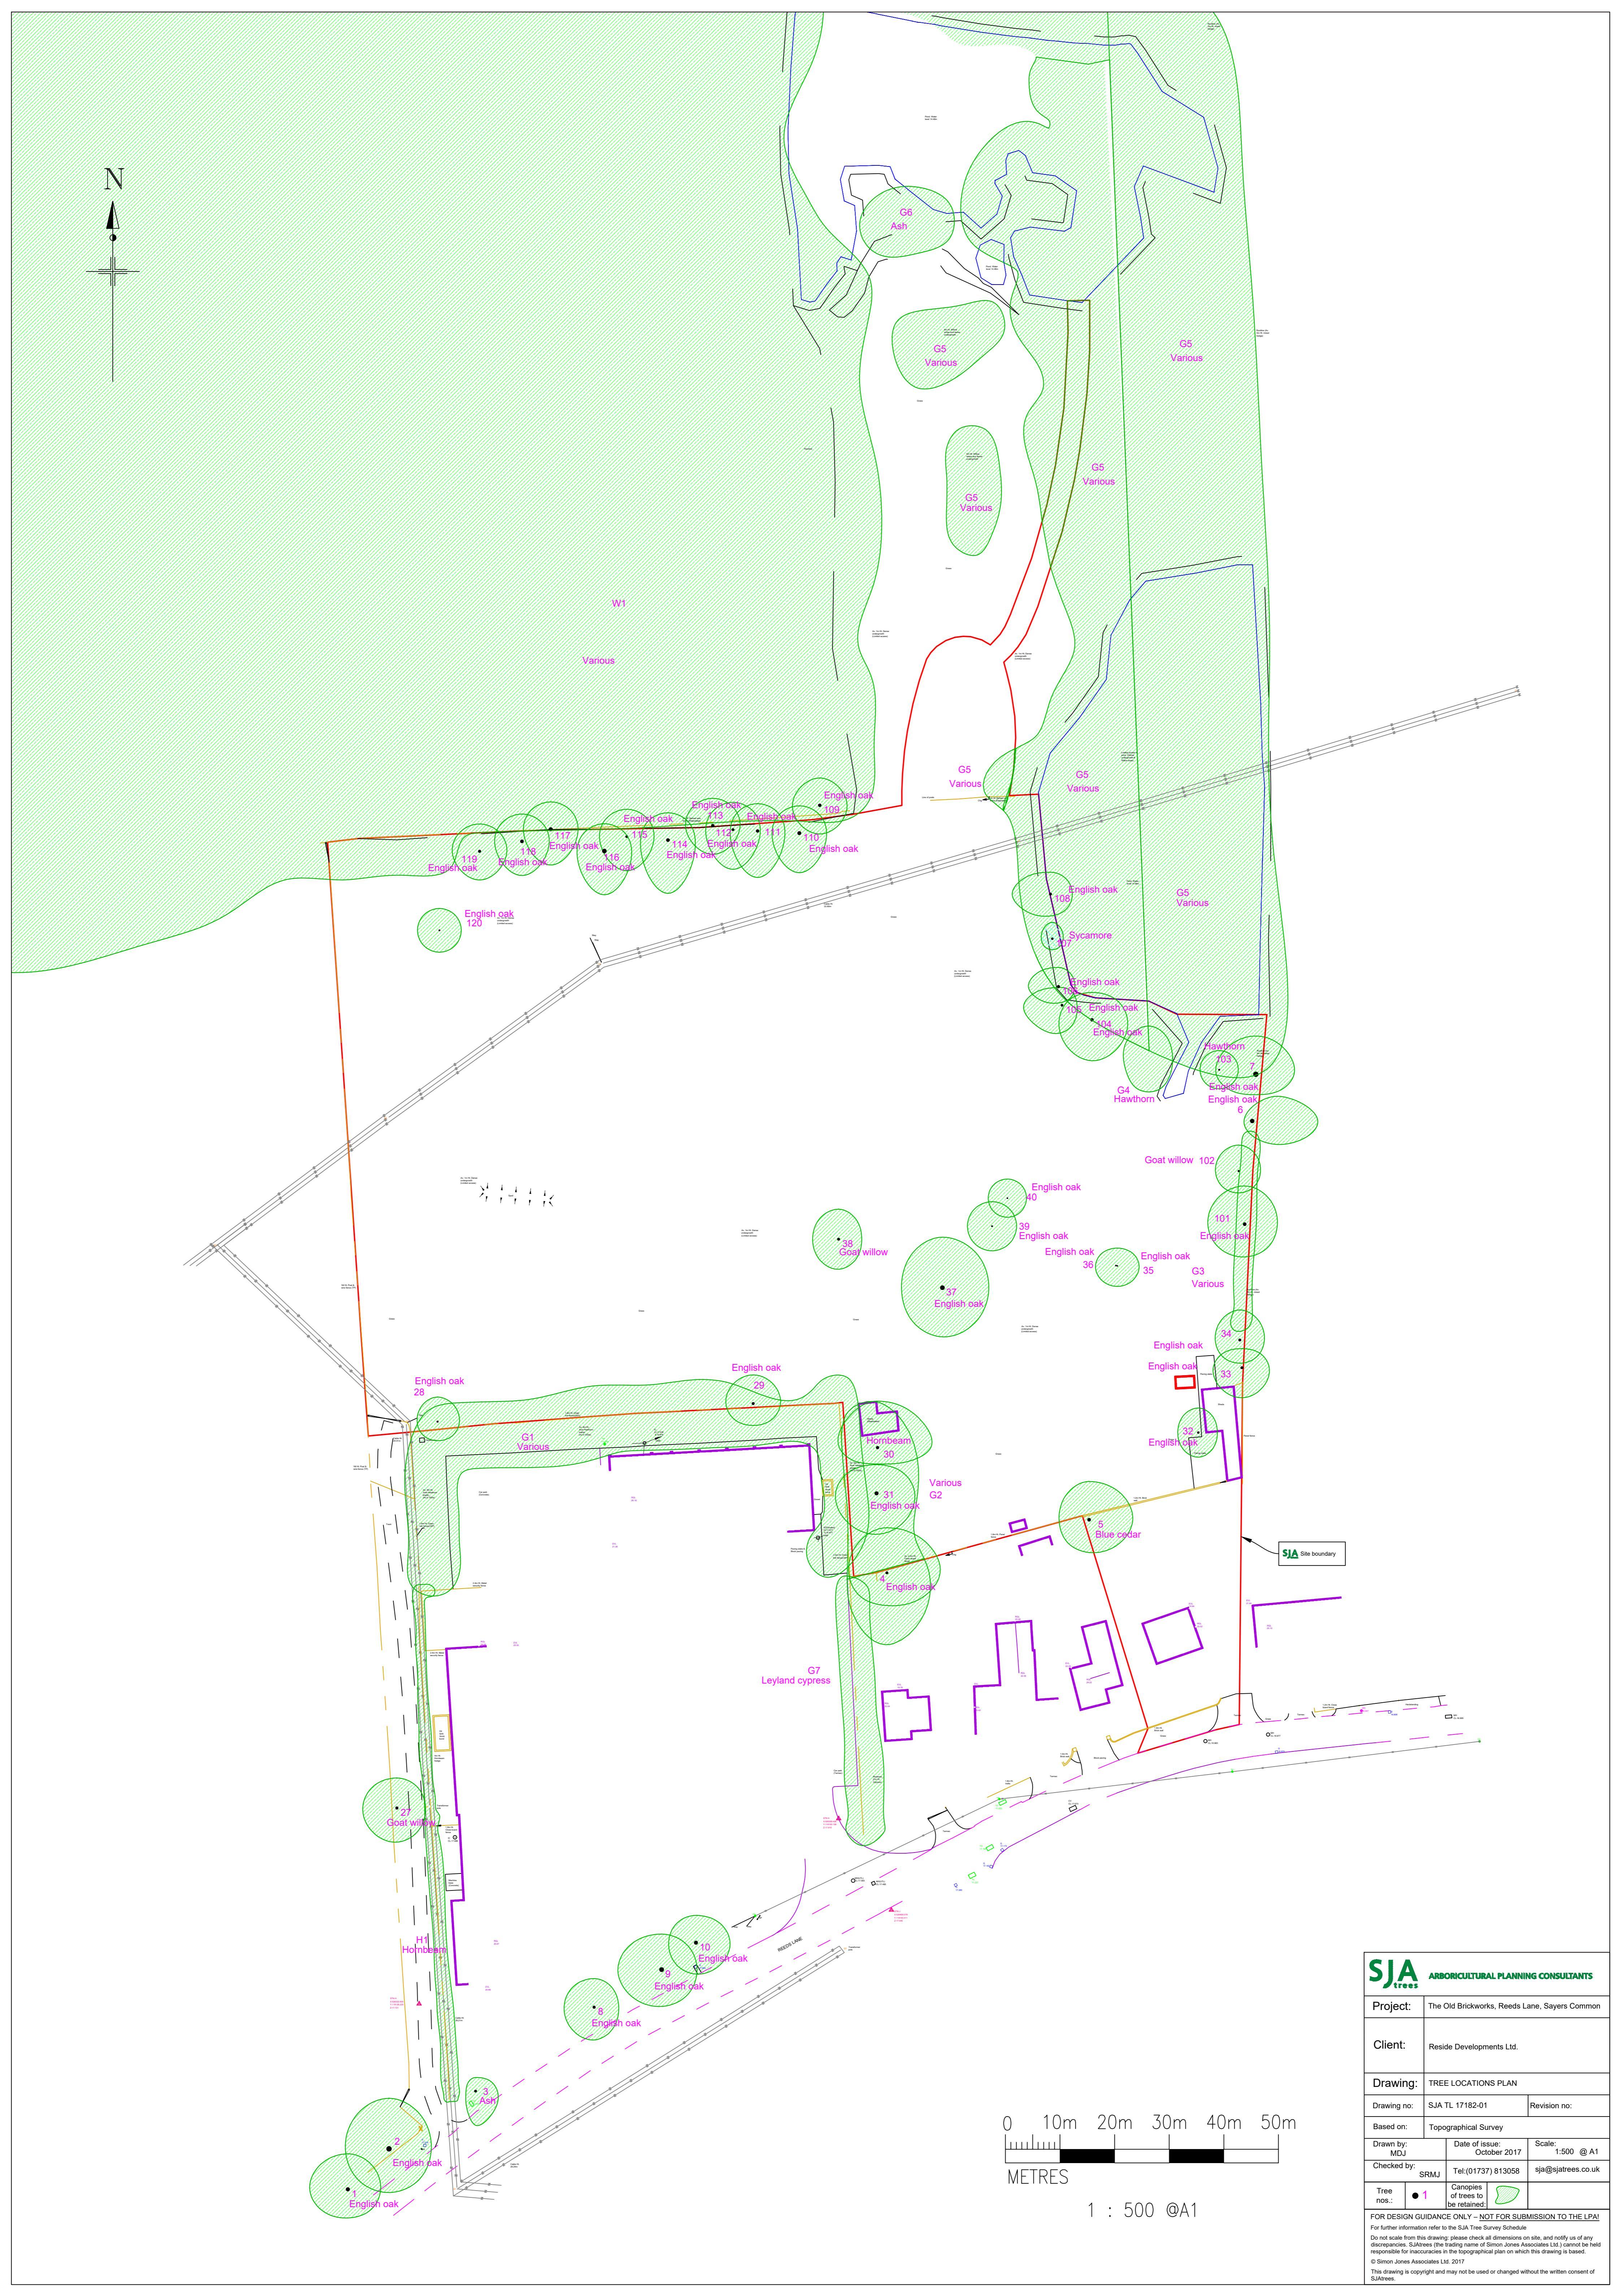
## APPENDIX 4 Tree Location Plan

2.4.1. The information in the tree survey schedule has been used to produce the tree locations plan at **Appendix 3**, which is based on the topographical survey plan provided. The locations of some additional trees, not shown on this plan, have been plotted using our own measurements taken on site.

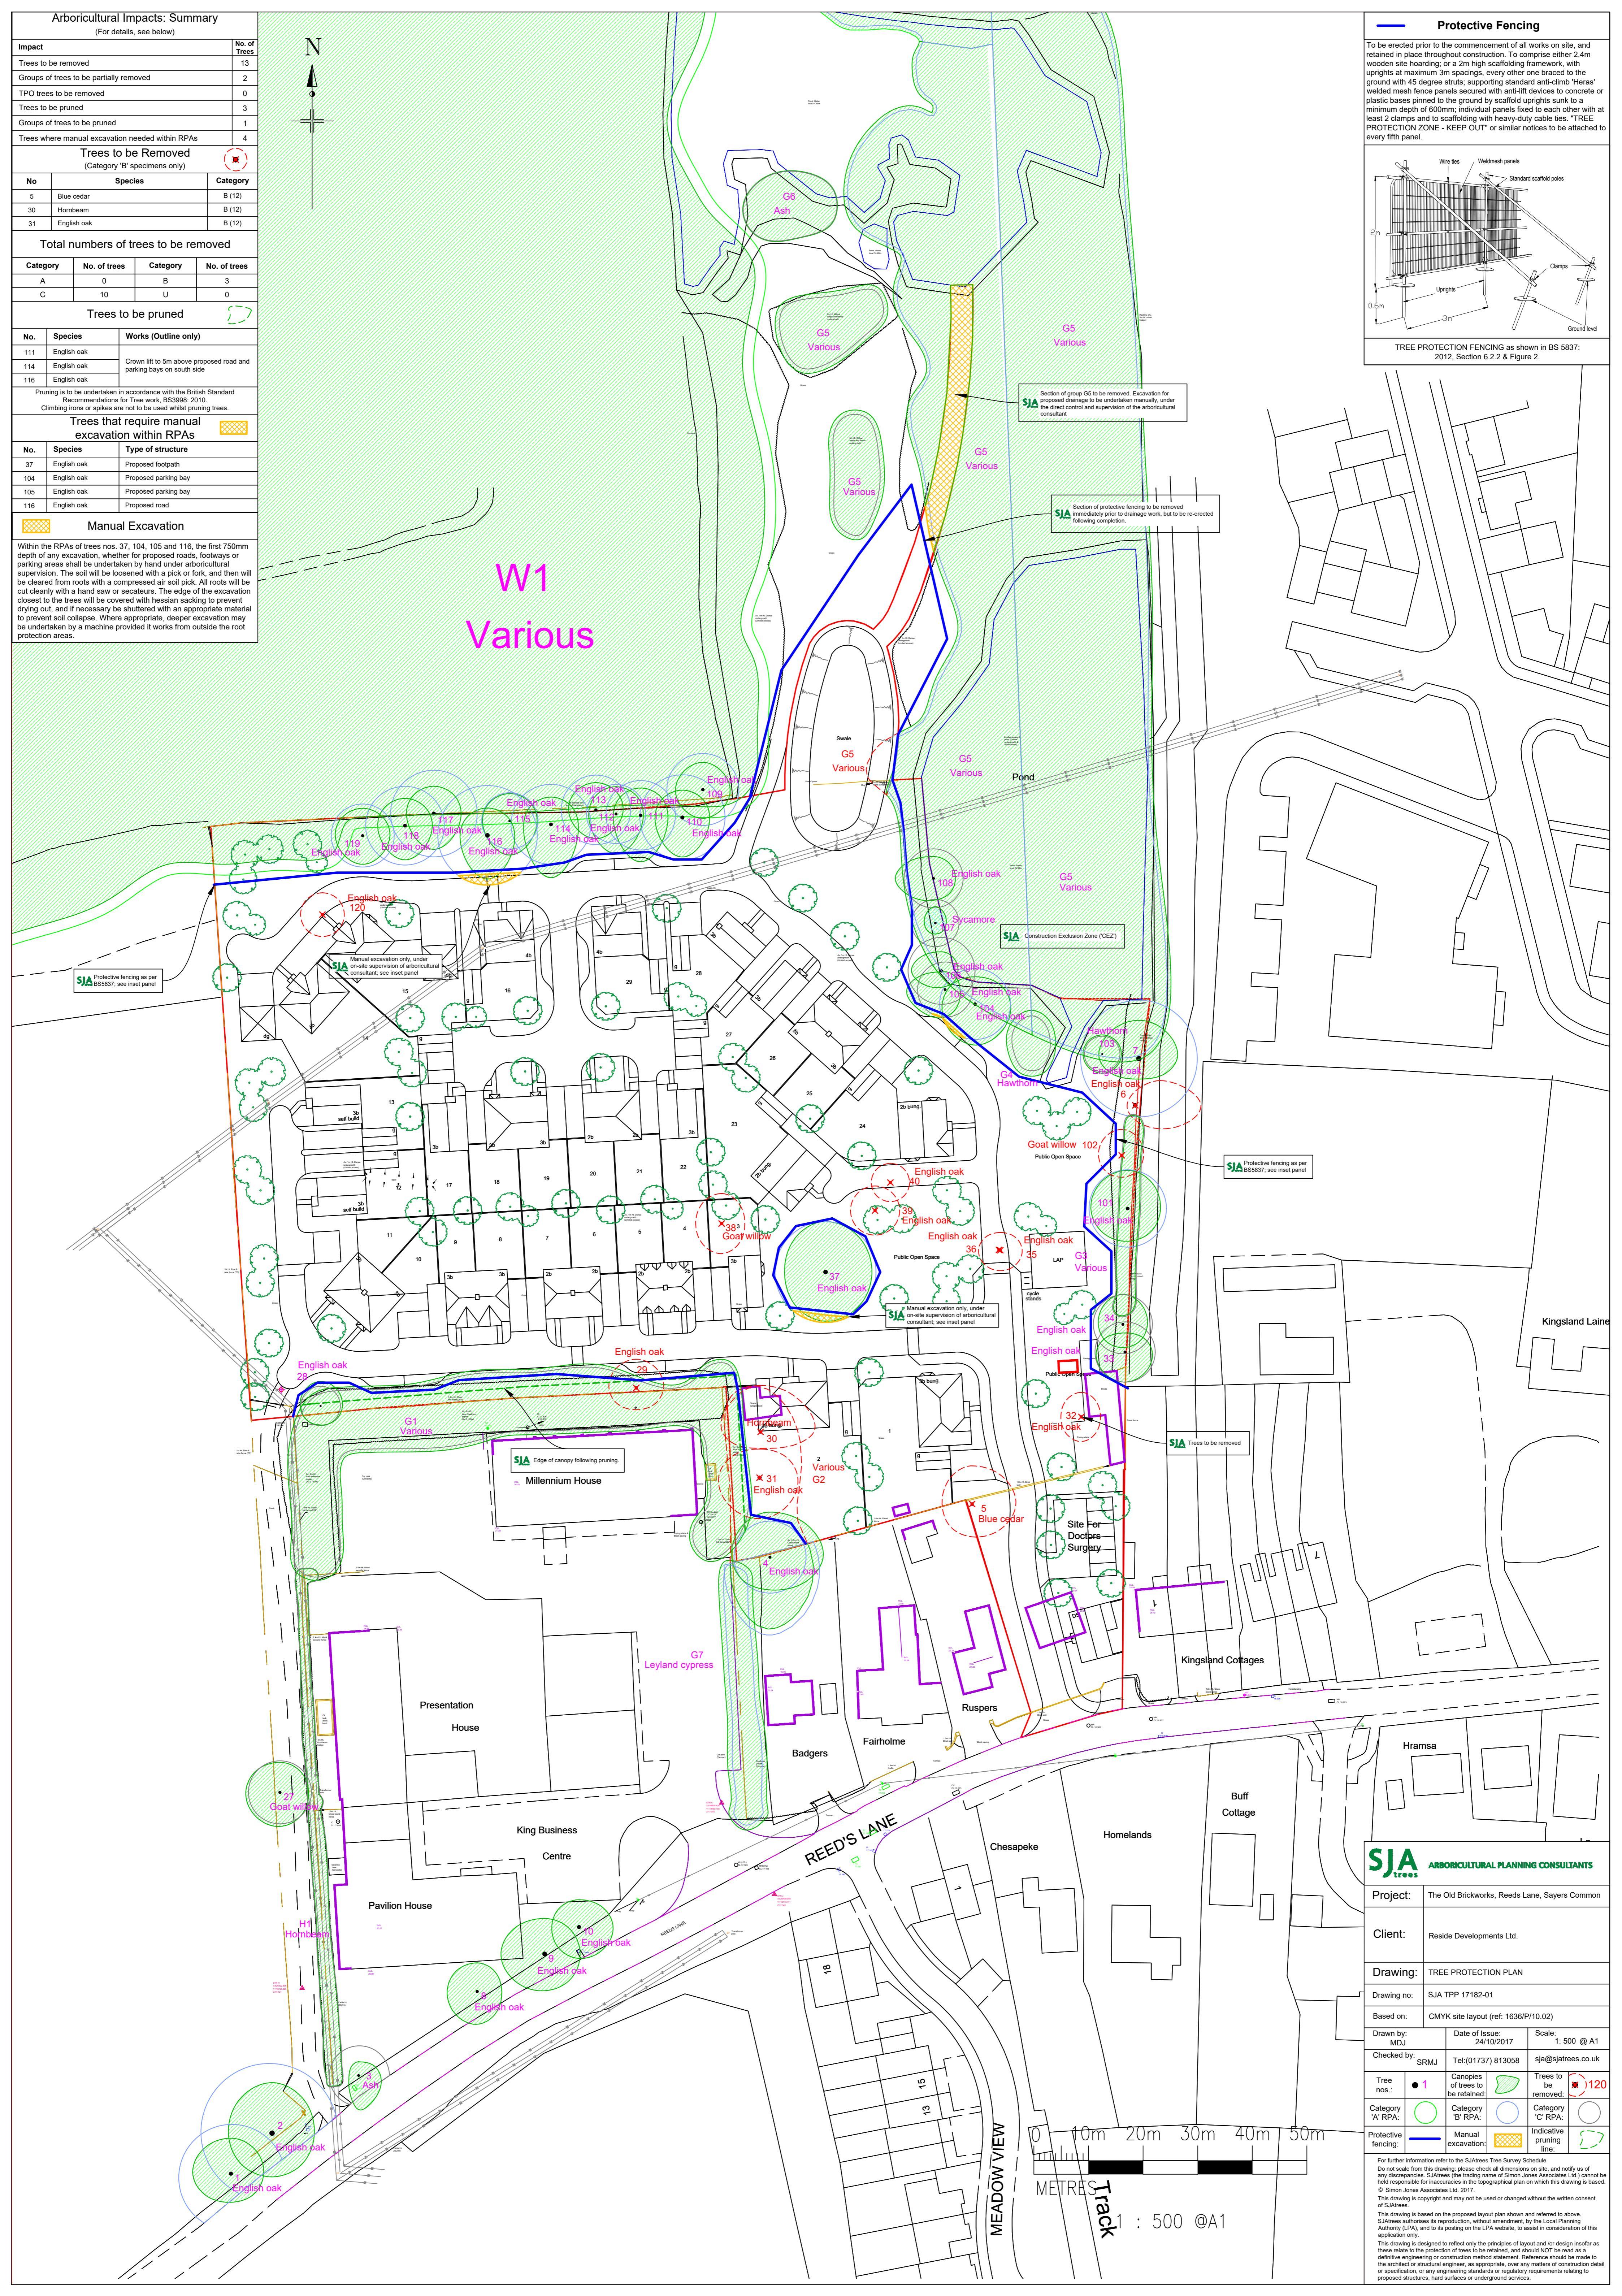
## APPENDIX 5 Tree Protection Plan

A1.1.1. The TPP at **Appendix 4** shows the general and specific provisions to be taken during construction of the proposed development, to ensure that no unacceptable damage is caused to the root systems, trunks or crowns of the trees identified for retention. These measures are indicated by coloured notations in areas where construction activities are to occur either within, or in proximity to, retained trees, as described in the relevant panels on the drawing.

A1.3.3. The recommended positions of the protective fencing are shown by **bold blue lines** on the TPP. The precise positioning of the fencing around the trees will be considered in conjunction with any other protective hoarding/fencing which may be required around the site boundary.

A1.4.1. The first 750mm depth of excavations required within the RPAs of the trees to be retained (as shown by **bold orange lines** on the TPP) will be dug by hand, using a compressed air soil pick if appropriate, and under on-site arboricultural supervision, in order to safeguard against the possibility of unacceptable root damage being caused to these specimens. Any roots encountered of over 25mm diameter will be cut back cleanly to the face of the dig nearest to the tree, using a sharp hand saw or secateurs, and their cut ends covered with hessian to prevent desiccation.

2.6.3. The TPP also shows how trees to be retained will be protected from damage during construction, and the measures identified are set out and described at **Appendix 1** to this report. The implementation of, and adherence to, these measures can readily be secured by the imposition of appropriate planning conditions.

A1.3.1. Construction exclusion zones (CEZs) will be formed by erecting protective fencing around the RPAs of all on-site trees to the specification recommended in BS 5837, Section 6.2, prior to the commencement of construction. This will consist of a scaffold framework comprising a vertical and horizontal framework, well braced to resist impacts, with vertical tubes spaced at maximum intervals of 3.5m. Onto this, welded mesh panels should be securely fixed with wire or scaffold clamps, as shown in **Figure 2** of that document. **"TREE PROTECTION ZONE - KEEP OUT**" or similar notices will be attached with cable ties to every third panel.
